Home Inspection Report

1234 Main St., South Bend, IN 46637

Tuesday, November 10, 2015

MER20151112-0

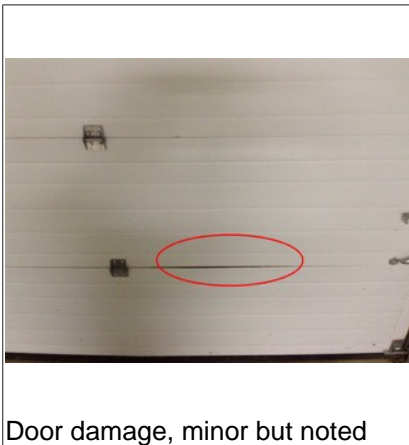
N/A
 Wood Fiberglass Masonite Metal Recommend repair
Condition Satisfactory Marginal Poor Hardware loose Safety Cable Recommended
 Weatherstripping missing/damaged Loose/missing
Recommend Priming/Painting Inside & Edges Yes No
Comments Garage door bottom section is damaged, does not impair the doors operation.
Photos

Door damage, minor but noted

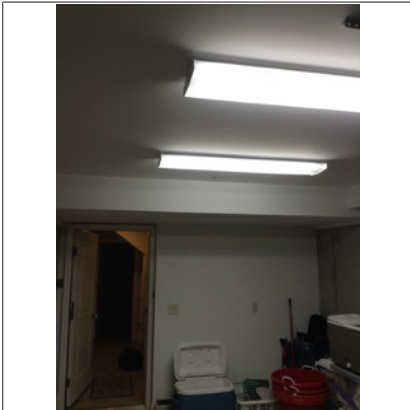
Fire approved wall and ceiling
finished drywall

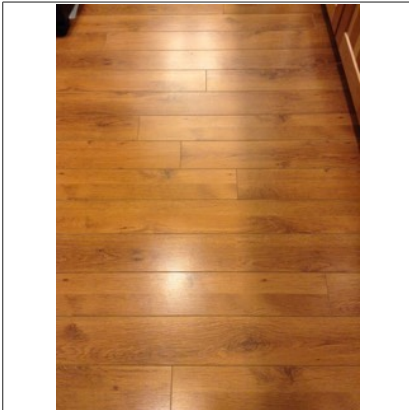
High quality, durable laminate flooring throughout unit

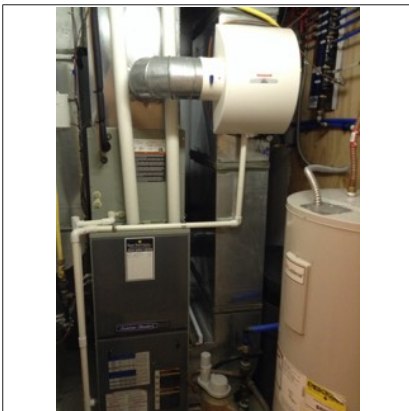
Utility room, main water shut off next to water heater

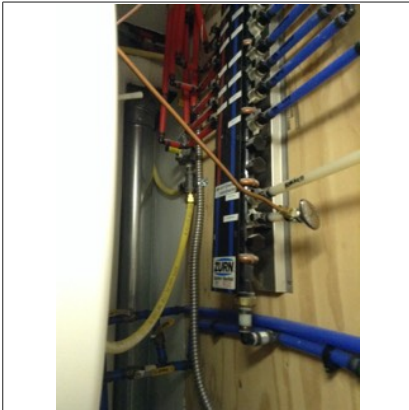
Main shut off gas line. A bit difficult to access

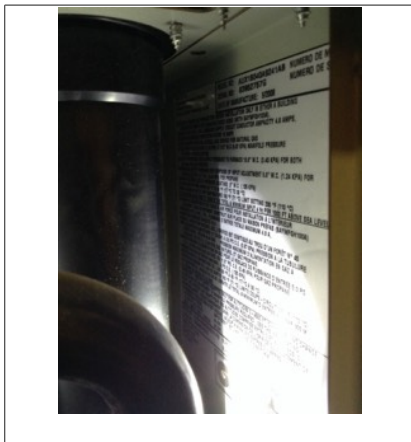
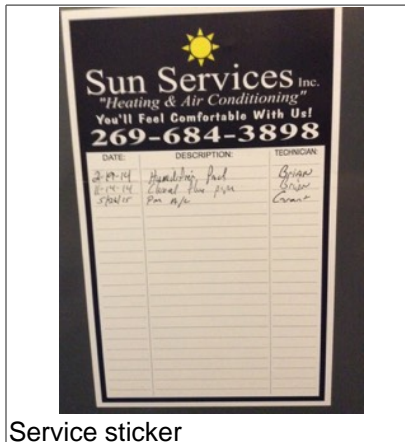
Comments 92percent high efficiency, regular maintenance schedule op to date. CO detector present in utility closet, and throughout unit.

Service sticker

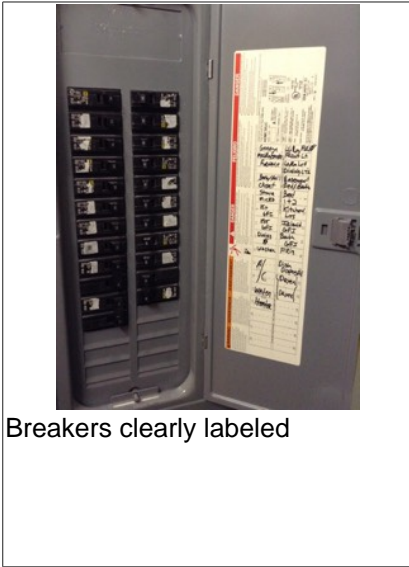
Breakers clearly labeled

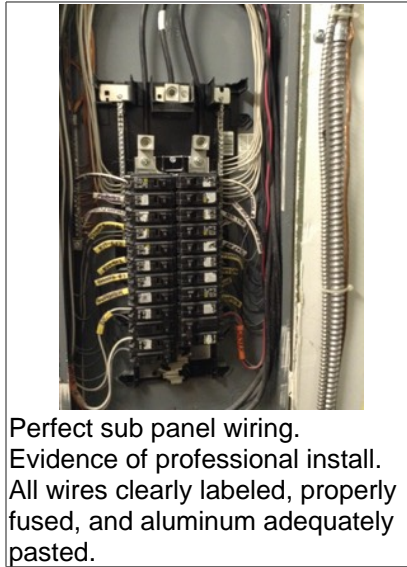
Perfect sub panel wiring. Evidence of professional install. All wires clearly labeled, properly fused, and aluminum adequately pasted.
