## Home Inspection Report

21 Main Street, South Bend, IN 46611

Sunday September 18, 2016

# Well/Septic

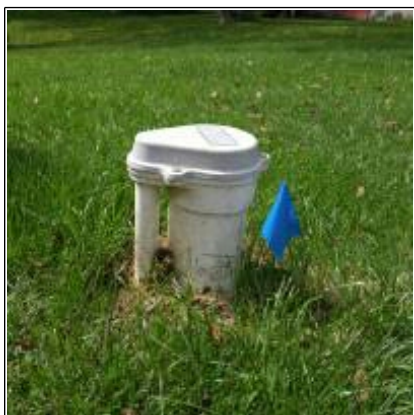
**Location** Off northwest corner of house

**Well head above ground**  Yes  No Measurement: 12in

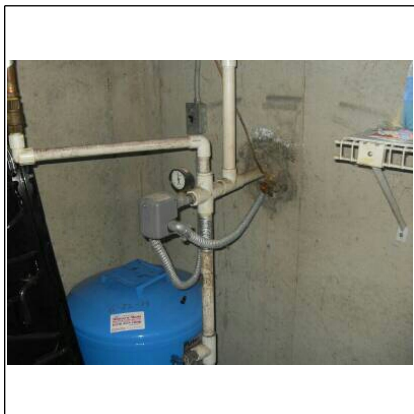
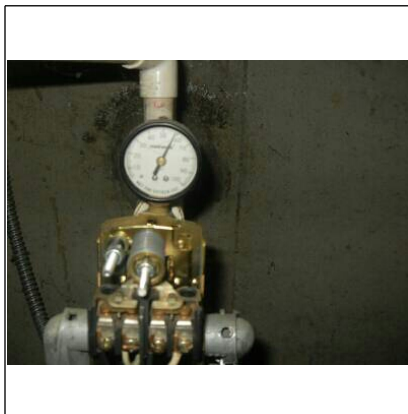
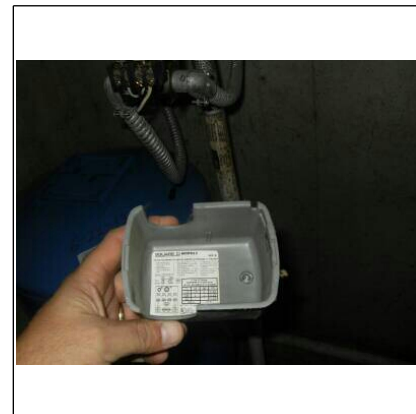
Observed pump cycle pressure parameters: 38-62 psi

**Comments** Bladder in tank maybe stretched, currently well is cycling nicely, switch is opening and closing smoothly, no arcing. If pump starts short cycling or running constantly while using water, you will need a new pressure tank.

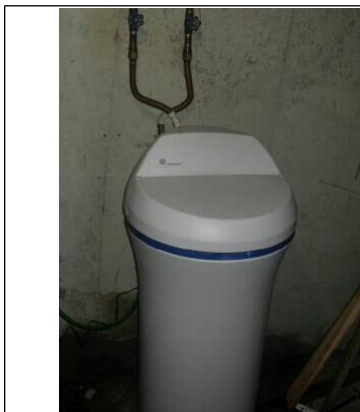
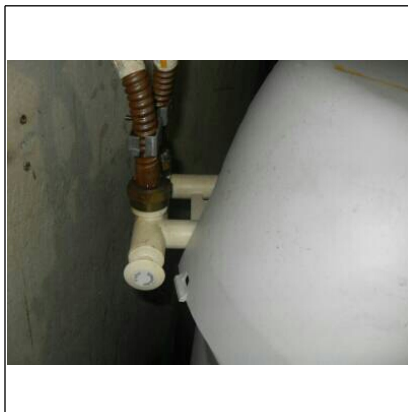
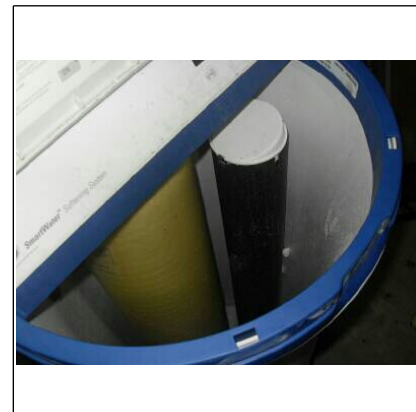
**Comments** Water softener needs maintenance before using, no salt in tank, unit has been neglected leaks constantly.

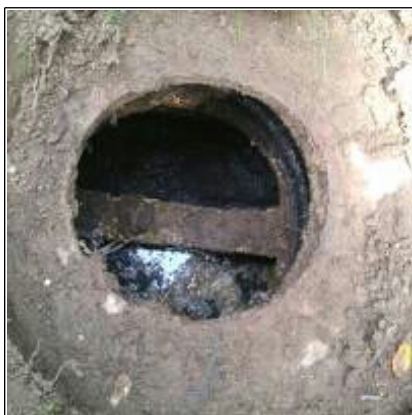
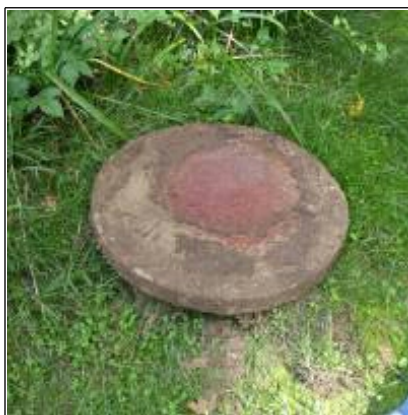
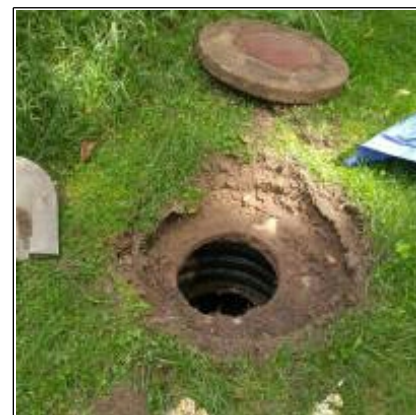
**Comments/measurements/** 4in scum measured 2in of sludge, tank should be pumped in about a year. baffles were not visible, but i ran 100 gal through tank and it passed easily.

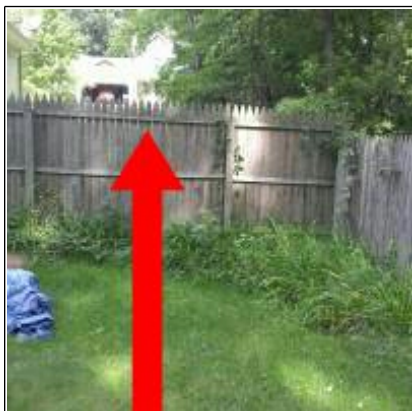
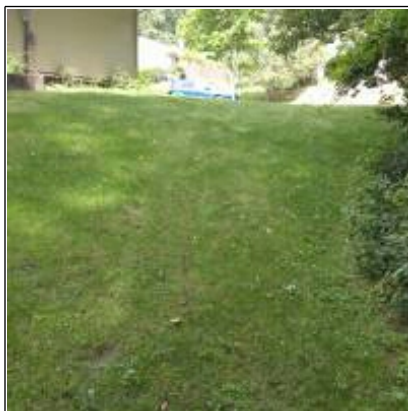
**Comments** Leach Field Observations: drain field is close to wooded area (within 20 ft). soil type is optimal for good drainage but is also subject to compaction. avoid driving or parking heavy vehicles along yard surface east of house.

Drain field runs up east side of yard from back yard.
